Chapter 5

Failure of mechanical shaft seals

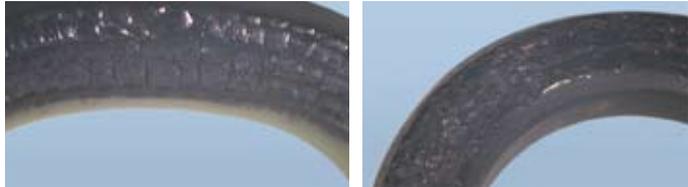
Fig. 5.3: Surface damage due to high temperature on EPDM and FKM secondary seals

Dry running occurs when there is no liquid around the seal, either due to the absence of pumped medium in the pump or poor venting, resulting in the formation of air around the seal. The absence of lubricating film causes the friction between the seal faces to increase. Consequently, the temperature rise dramatically.

As there is no pumped medium in contact with the seal rings, the heat must be transported away through the seal. Many seals with hard seal faces reach a temperature of several hundred degrees Celsius on the seal faces within few minutes. The typical damage caused by dry running is burnt elastomeric parts. The damage occurs where the O-ring is in contact with the hot seal ring. See fig. 5.3.

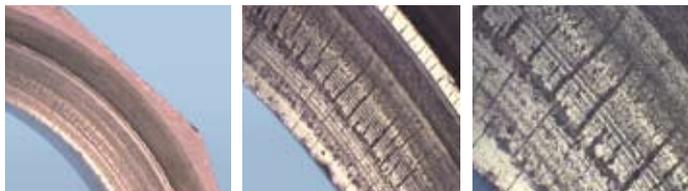
Fig. 5.4: Severe thermal cracks in WC seal face caused by poor lubrication

Similar to dry running, the frictional heat generated on the seal faces as a result of poor lubrication may also cause problems. Poor lubrication may occur when the viscosity of the pumped medium is very low or if the temperature is well above the boiling point at atmospheric pressure.

Under these conditions, the frictional heat dissipating in small areas on the seal face can be very high. The alternating local heating and cooling of the seal faces may cause small, radial, thermal cracks in the seal faces. See fig. 5.4.

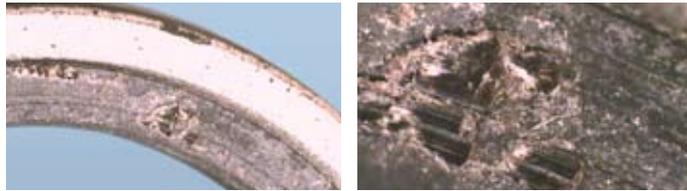
Fig. 5.6: Deposits on carbon graphite seal face

Some suspensions and solutions tend to cause build-up of scattered deposits on the seal faces. As the deposits only cover part of the seal faces, the sealing gap opens correspondingly. The result is a leaking shaft seal. The leakage is small at the beginning, accelerating as more liquid passes the sealing gap. The settlement accelerates, because the temperature is higher on the surface of the already anchored deposits. See fig. 5.6.

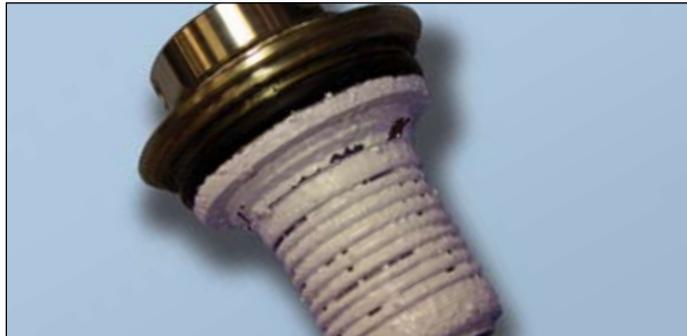
Fig. 5.7: Metal bellows seal clogged by lime scale build-up

When the pumped medium has a high content of suspended particles and fibres, the seal can fail due to precipitation or consolidation of the particles and fibres on or at springs, bellows, seal-drivers or O-rings. The sedimentation rate is affected by the pumped medium and the flow conditions around the seal. In extreme cases, the sedimentation on metal bellows shaft seals may prevent the axial spring action of the bellows. Subsequently, the seal can open when the operating conditions are changed. See fig. 5.7.

If a change in operating conditions necessitates an axial compression of a bellows clogged by sediments, the closing force of the seal can be extremely high. This may result in excessive mechanical stress on the seal components or failure due to poor lubrication.

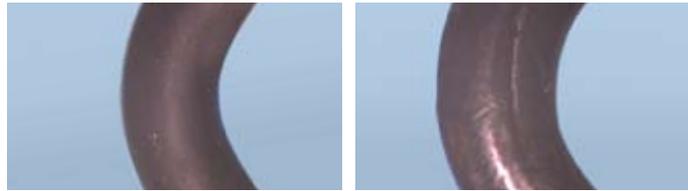
Fig. 5.8: A fresh EPDM O-ring (left) and a swollen EPDM O-ring (right) exposed to water containing mineral oil

Swelling of rubber is an increase in volume and a decrease in hardness due to absorption of a solvent. The volume increase depends on the type and grade of rubber, the type and concentration of the solvent as well as the temperature and time of exposure. In extreme situations, the linear dimensions of a swollen rubber part can be doubled.

The commonly used EPDM rubber material shows a high degree of swelling when exposed to mineral oil. EPDM swelling takes place irrespective of the concentration of mineral oil in water, however, the lower the concentration level, the longer the period of operation before failure. See fig. 5.8.

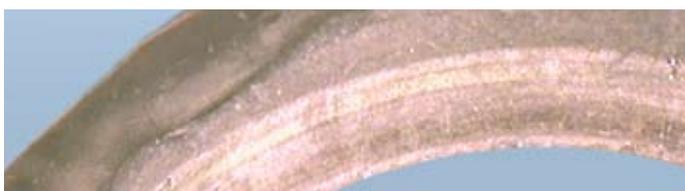
Fig. 5.10: Corrosion of the binder phase followed by severe erosion on a tungsten carbide seal ring with cobalt binder phase

On other surfaces of the seal rings, heavy erosion can occur where the binder phase is corroded. See fig. 5.10. In stainless steel pumps and pipe systems, tungsten carbide with cobalt binder corrodes in tap water.

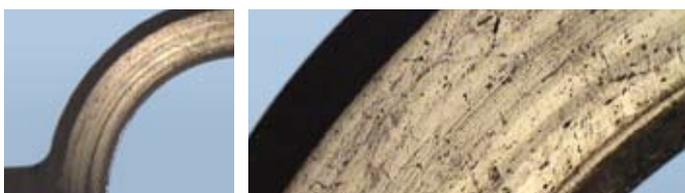
Fig. 5.11: Normal wear on surface of tungsten carbide seal ring

Because the thickness of the lubricating film is of the same order of magnitude as the surface roughness, the seal faces will wear to some extent. This normal wear on well-performing seals will be so small that the seal will be able to survive for many years. See fig. 5.11. In special cases, wear can cause problems, but often seals work perfectly with severe wear up to 0.5–1 mm, even with heavily grooved seal faces, as long as the axial flexibility of the seal ring is maintained.

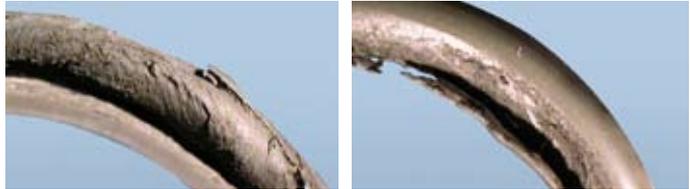
Fig. 5.19: O-rings extruded on account of high pressure

Extruded O-rings is a commonly known failure mechanism. If the temperature approaches the maximum operating limit of the rubber, the rubber material becomes softer and thus susceptible to extrusion. See fig. 5.19.
